CONDITION ASSESSMENT AND ASSET MANAGEMENT OF THE WEST DERWENT PIPELINE

Sarah Furman (Maunsell Australia Pty Ltd), Simon McCrossen (Hobart Water), Sandy Muir (Maunsell Australia Pty Ltd), Russell Fox (Hobart Water)

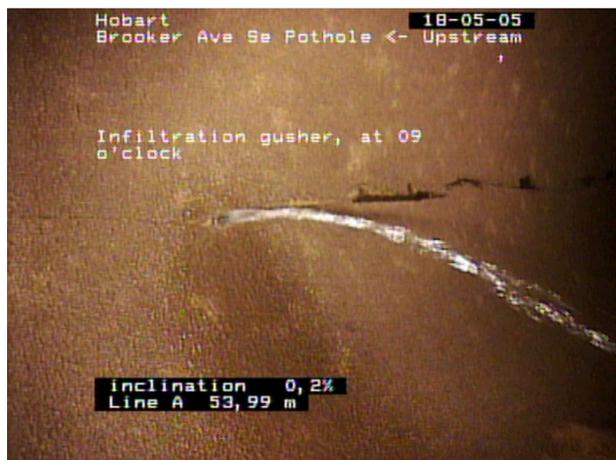
Figure 1: Infiltration leak

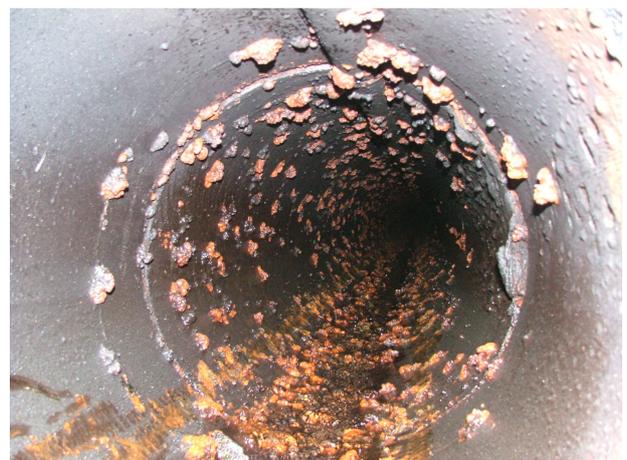
Figure 2: Corrosion at defects in the internal coating
