# INNOVATION IN PIPELINE ASSET MANAGEMENT

Sarah Seel, Sandy Muir and Russell Fox

Maunsell Australia Pty Ltd and Hobart Water

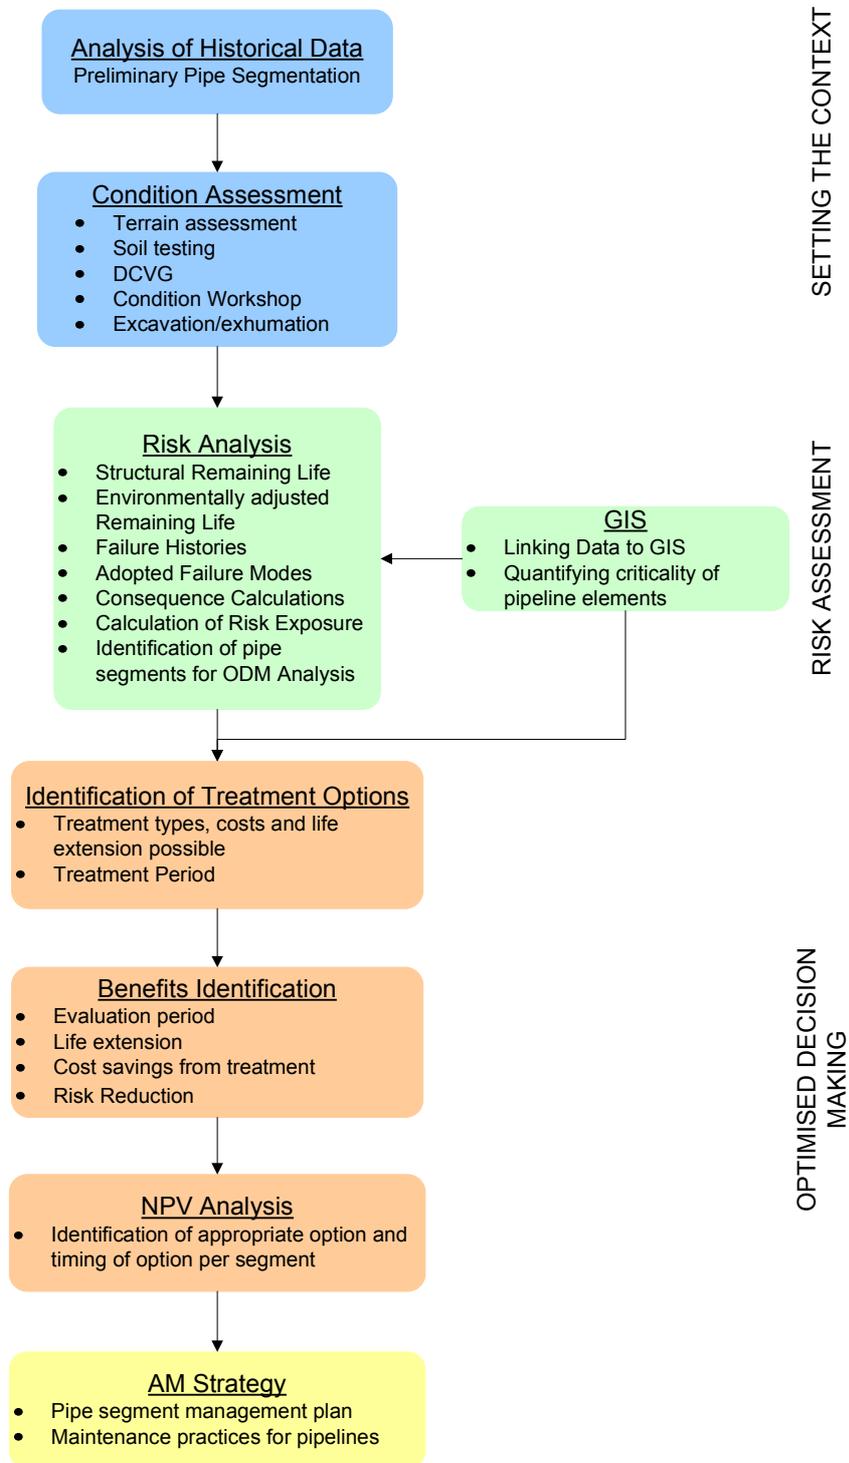
**Figure 1:** West Derwent Pipeline Strategy

The approach taken is summarised in Figure 1 and is described in detailed in the following sections.

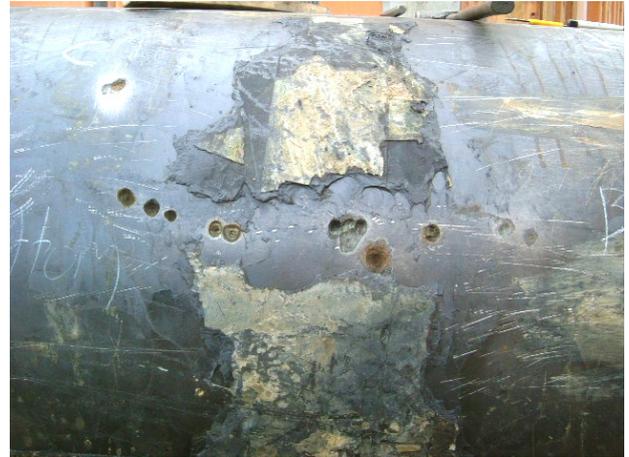
Stage 2 involved exposing the pipeline at select locations and physically assessing the condition of the external coating on the pipeline and the extent of corrosion. At selected sites the external surface of the pipeline was assessed at the crown and invert for wall thickness, and depth and distribution of corrosion pits, following removal of the pipeline coating. Examples

showing the variation in the condition of similar aged pipelines are shown in Figures 2 and 3.

**Figure 2:** Pipeline with several small perforations located in a highly aggressive environment with defects in the pipe coating.

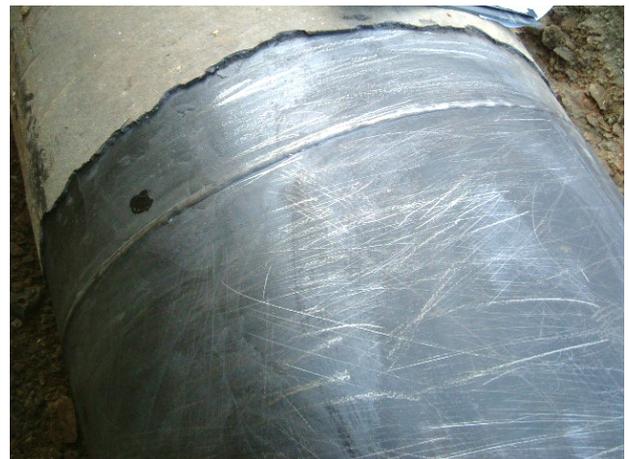
**Figure 3:** Pipeline in very good condition showing no evidence of corrosion. The pipeline was located in a slightly aggressive environment with no defects in the coating.

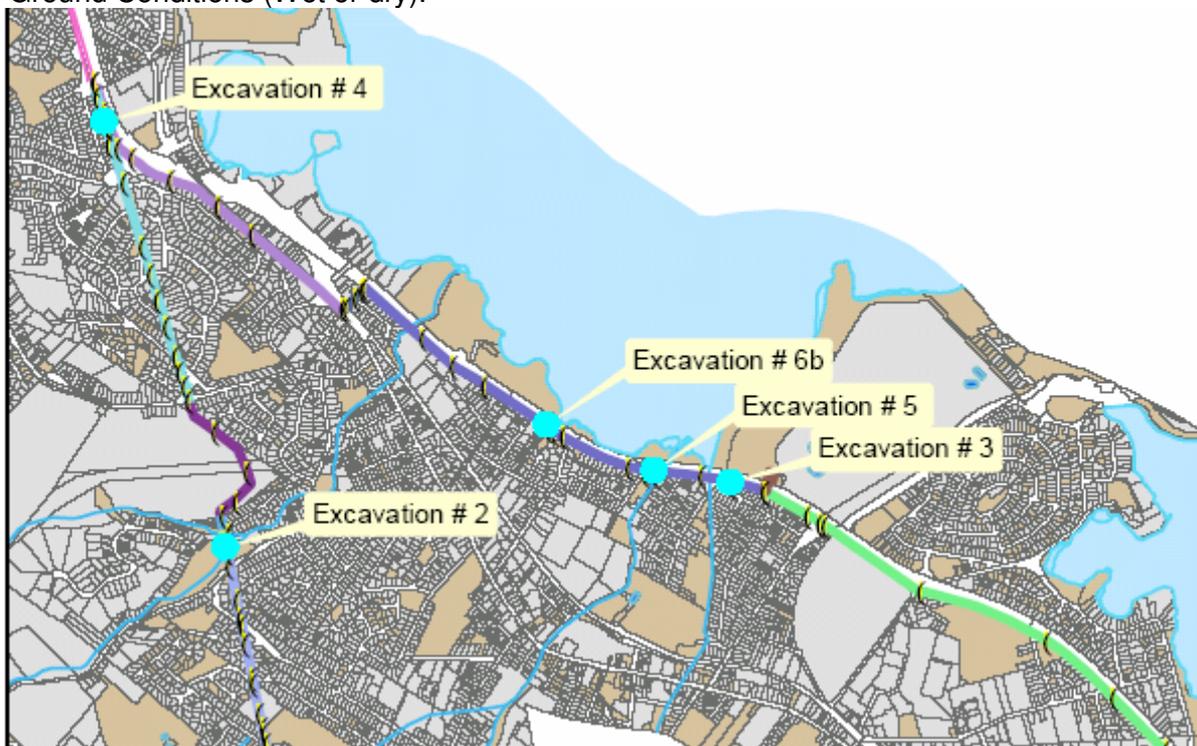
An example of the excavation locations and criticality and risk assessment data displayed on the GIS is shown in Figure 4 and 5.

**Figure 4:** GIS map showing some of the physical inspection locations.

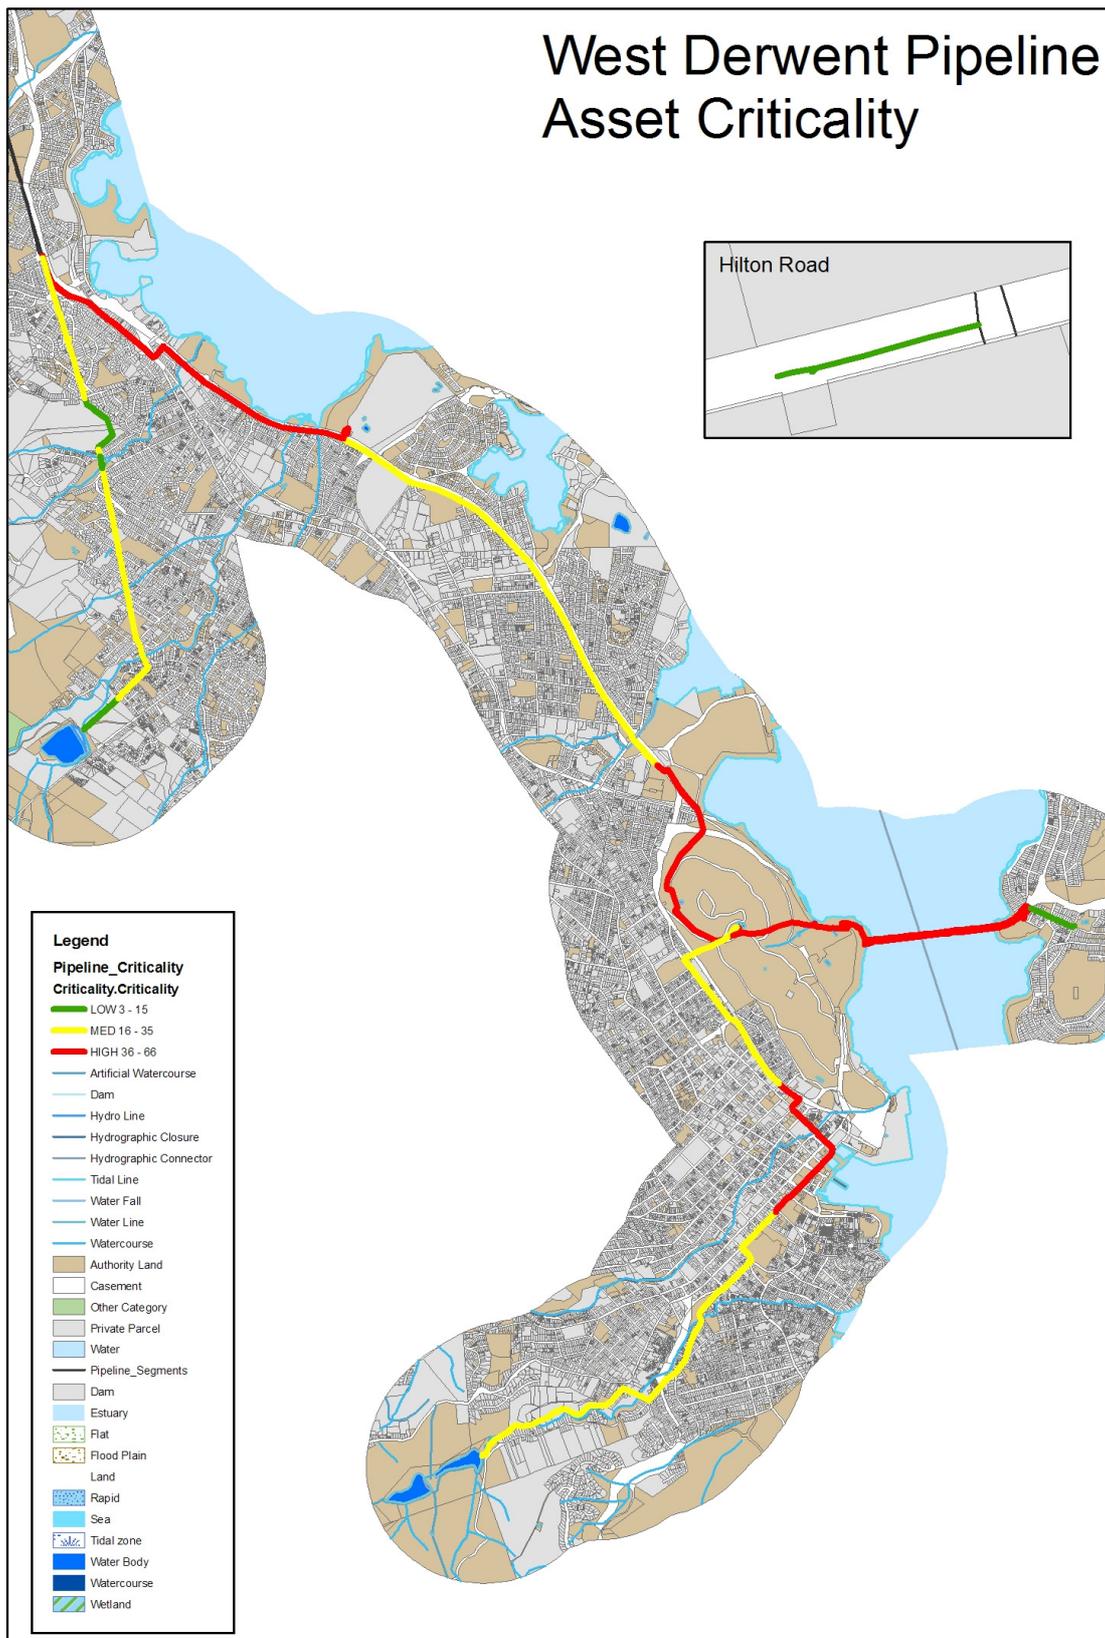
Figure 5: West Derwent Pipeline Asset Criticality

Each parameter was rated individually for each pipe element and then aggregated to give a criticality score. Ranking of the scores for each pipe segment provides Hobart Water with a list of assets that potentially have the greatest impact on the business should they fail.

The criticality of each element was plotted on the GIS and the results of this assessment are shown in Figure 5.
